**REBUILDING RETAINING WALL AT ST ANDREW'S CHURCH, KIRKBY
MALZEARD**

HERITAGE STATEMENT

Report 18523-Y-RP-003

Rebuilding retaining wall St Andrew's Church, Kirkby Malzeard STRUCTURAL APPRAISAL REPORT

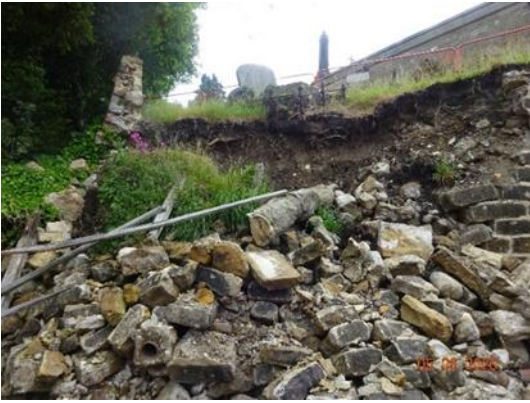
- 1.1.2 The northern end and corner is to be rebuilt following collapse and the southern 30m section is to be repaired and repointed following rejection of the original proposal to restrain the section of wall between the collapse and church tower with soil nails fitted with surface mounted patrix plates.

Collapsed section to north corner

- 1.1.3 The scheme is to rebuild the collapsed section of wall. This will be 700mm thick at its base and consist of an a proprietary 256mm wide precast concrete block (Stepoc) with reinforced cavity construction with reclaimed stone face outer leaf built off a 1000mm wide reinforced strip foundation. Lateral support to the wall will be provided by passive soil nail anchors. The outface stonework will be rebuilt with a slight outward bulge to align with the section being retained which will aesthetically assist blending in the rebuilt section of wall with the retained section.

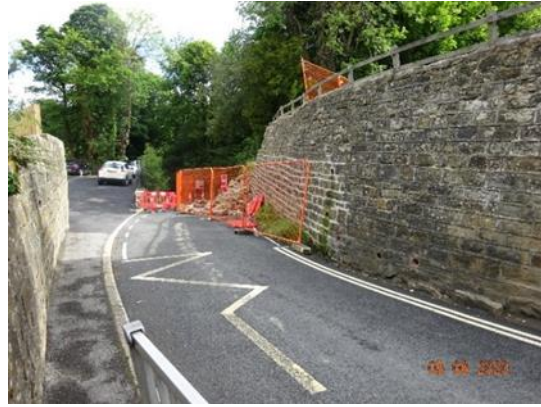
View look north along the street
